# Hydraulic headache

Gilbert Park shows how he replaced his boat's hydraulic hoses following a steering failure

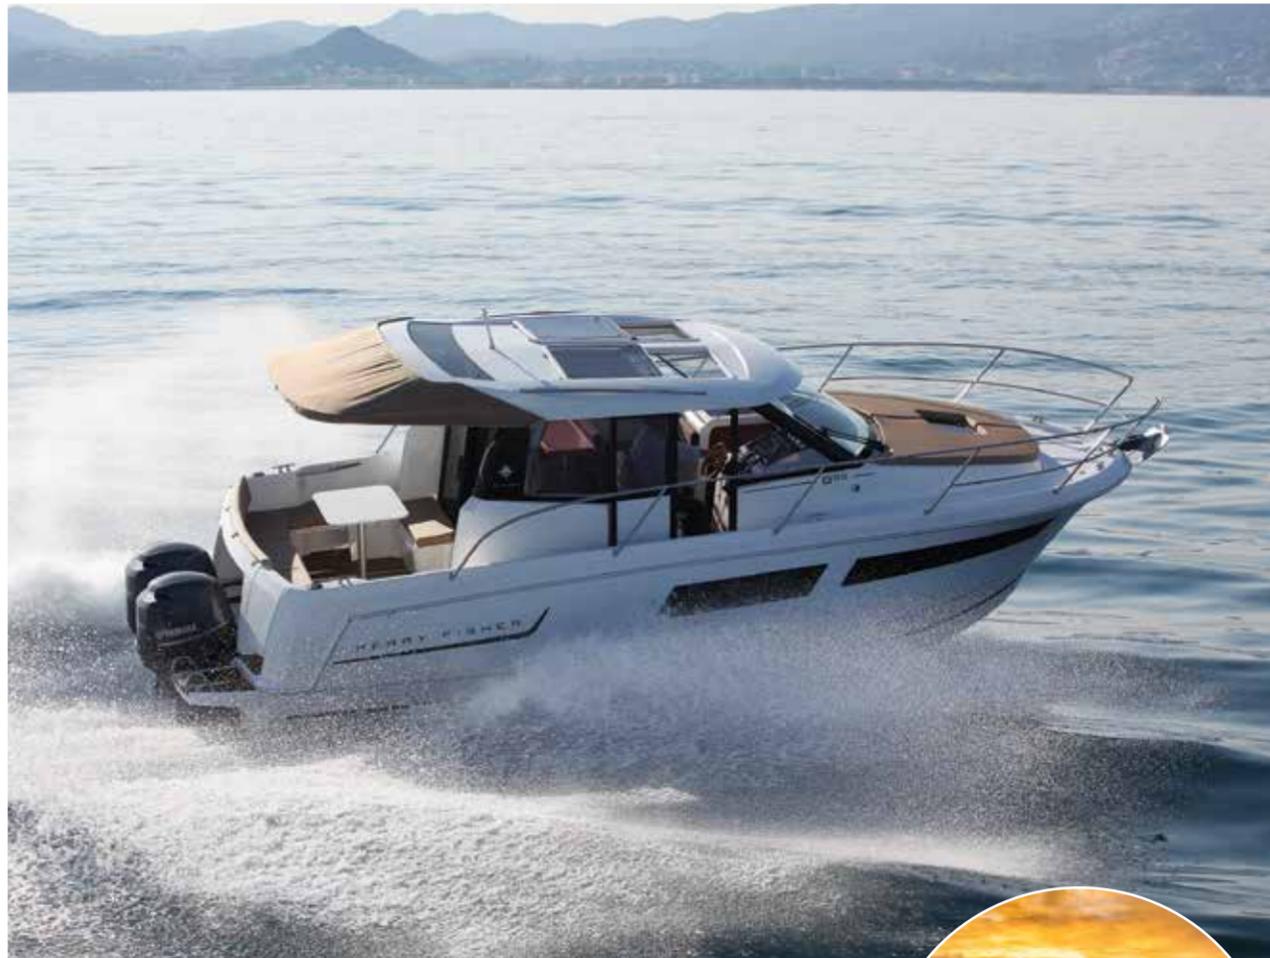
**ABOVE** Gilbert Park's Jeanneau Merry Fisher 855 lost steering when a hydraulic hose ruptured

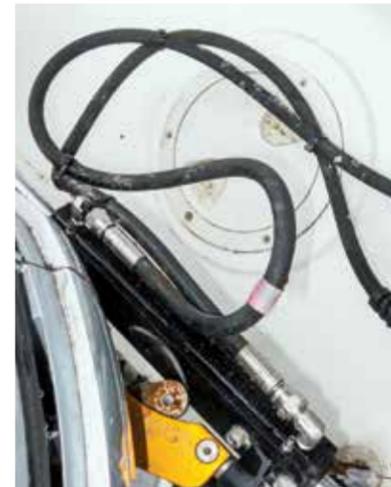
Looking at the hoses it became apparent that there was a hole in one where the manufacturers had put a right angle bend and a cable tie. There was a further cable tie holding the hose in position. This resulted in excessive flexing of the hoses with cracking of the outer core exposing the wire reinforcement that rusted away. The loss of strength once this had occurred meant rupture of the hose was inevitable. Fortunately I was able to get a tow to the waiting berth.

There's a right angle bend in the flexible hose near the cable tie – and that proved a weak spot under constant movement when the boat was being steered

I carefully marked the connections and once I'd removed the hoses I took them to Pirtek. They suggested that instead of fabric covered, wire reinforced tubing I instead use nylon hoses that wouldn't suffer the same problem. Stainless steel connectors were not in stock, but were ordered for the next day. In addition, I bought a screw-in spigot for the oil reservoir and a right angle connector to avoid a repeat of the problem.

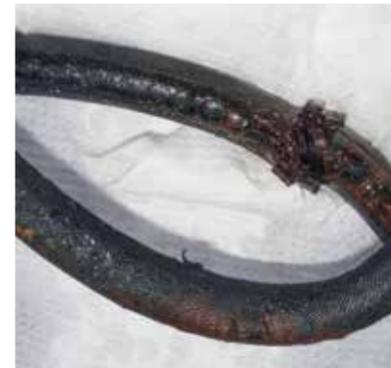
After removal the hole is clearly seen along with the rusted ends of the wire reinforcement. The lower hose also shows rust staining indicating that its inner core was deteriorating as well

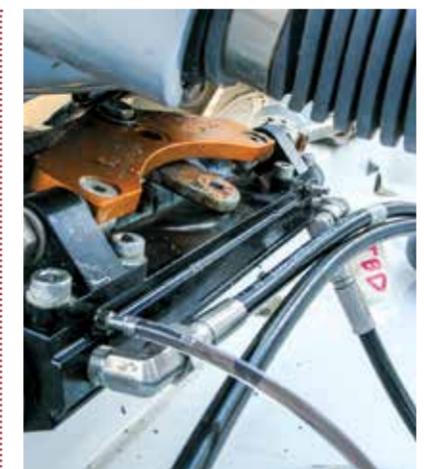
**6** Bleeding the system from both the port and starboard bleed nipples at first produced black oil that was obviously way past its best.
